# Manhole Inspection Summary

Manhole # S65M\_\_006MH

Insp Date: **4/24/08 3:02 PM**

**Location** Address: **1110 Anglesea St.**

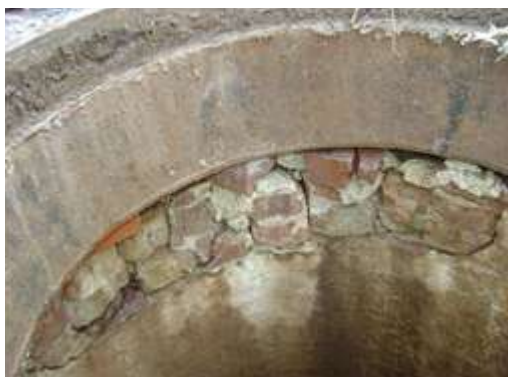
Defect 1

Condition: ☐ Sound ☐ Cracked ☐ Root Intrusion ☒ Loose Brick ☒ Deteriorated

Loose bricks at frame adjustment

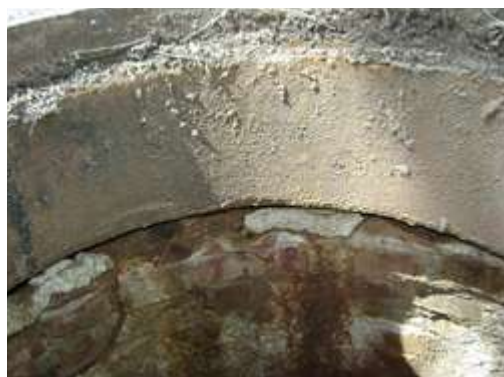
Defect 3

Infiltration: ☐ None ☒ Joint ☐ Cracks ☒ Mortar ☐ Roots ☐ Wall

Infiltration in chimney

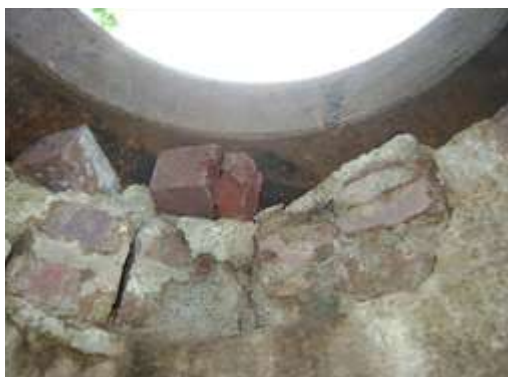
Defect 4

Loose bricks and missing mortar under frame

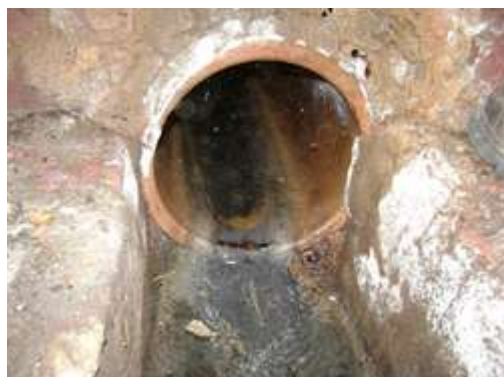
Defect 5

holes in pipe seal 2:00 on incoming 3 o'clock

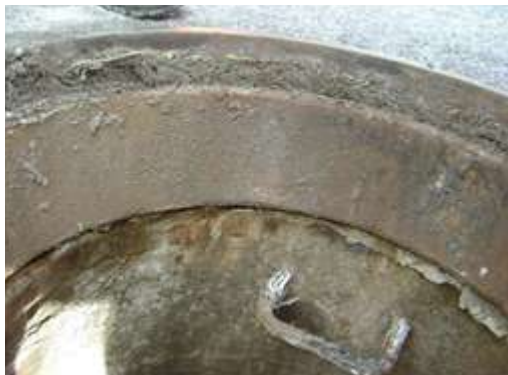
### Defect 2

evidence of infiltration

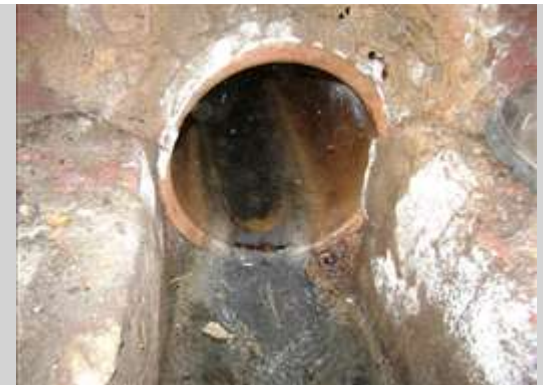
3 O'Clock Inflow

Pipe Height: **8.4** (in.) Rod and Bar (Angled)  
Pipe Material: **Clay** ☐ Pipe Lined  
Invert Depth: **9.25** (ft.) Flow Characteristics: **Slow**  
Deposits: ☒ None ☐ Mud ☐ Sludge ☐ Debris ☐ Grease  
Silt Depth: (in.) Deposits Extent:  
Infiltration: **None** Pipe Seal Cond: **Broken**
